Value Logistics
Blocked 75mm Storm Water
downpipes on roof
All caused by solid concrete – tile
grout & stones stopped storm
water from discharging –

This resulted in the boardroom
flooding

Solutions by Sam Dubazana
& Deon Pohorille

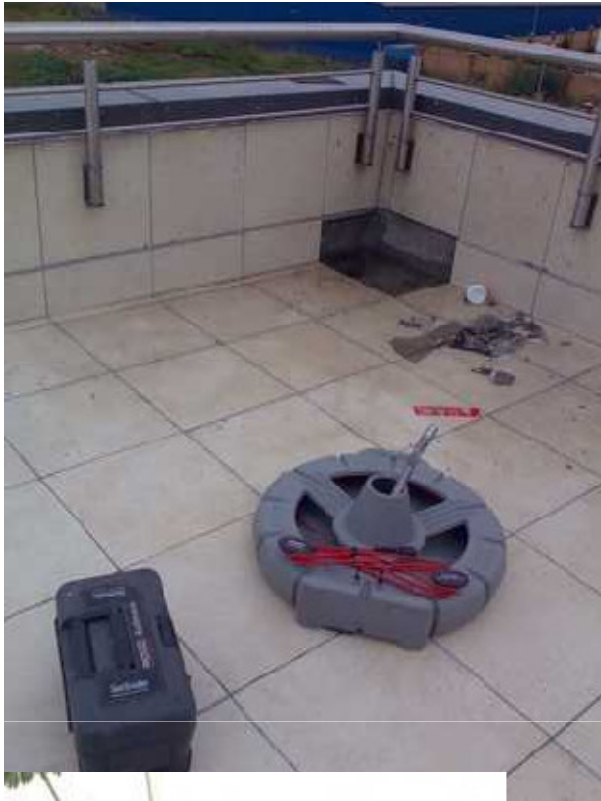
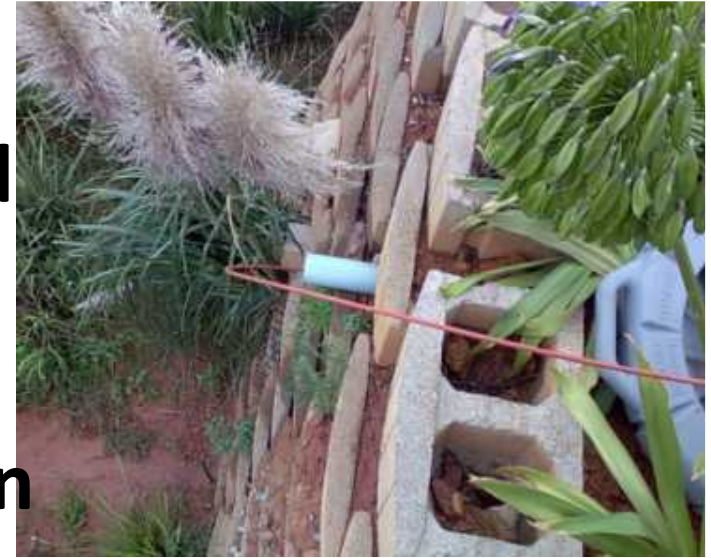
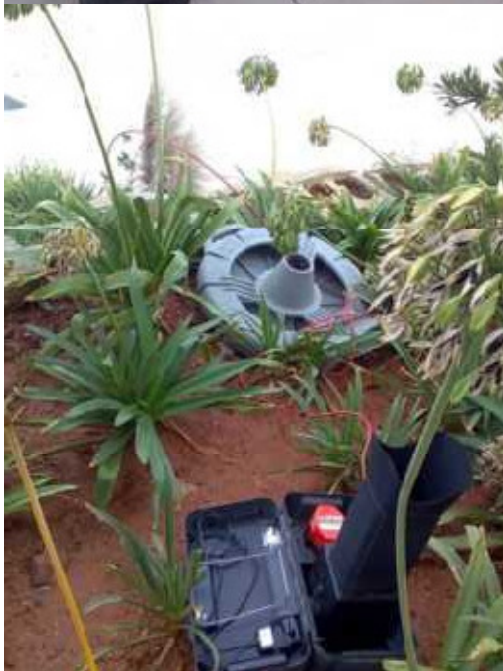
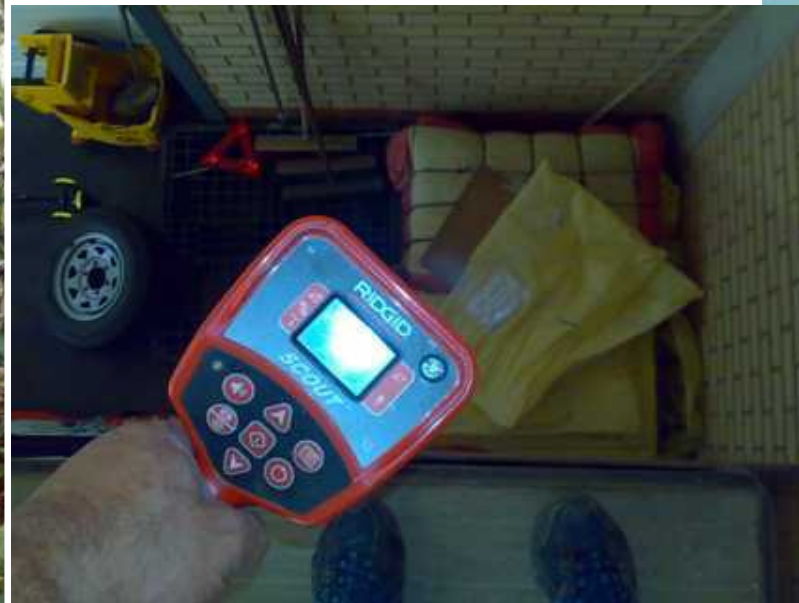
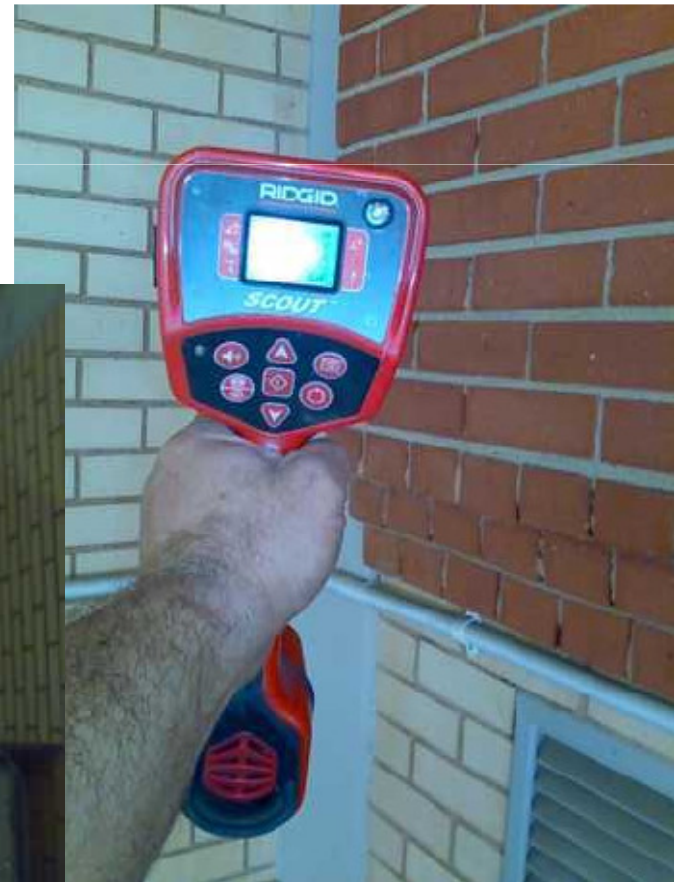
Advanced fiber optic camera and location devices used to pinpoint the exact location of solid blockages in Columns in factory

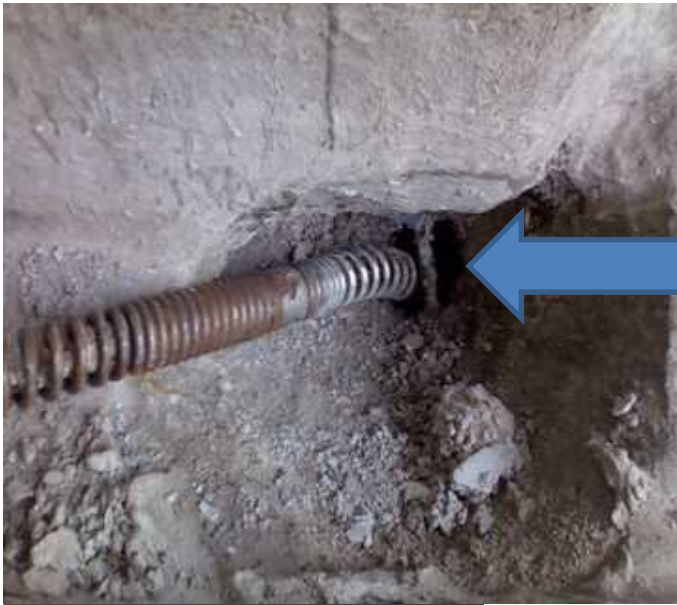
22mm spiral driven by Rothenberger machine used to partially unblock and dislodge cementitious blockages

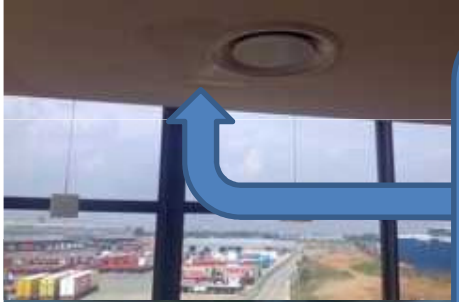
Board room Ceiling damaged from blocked drains

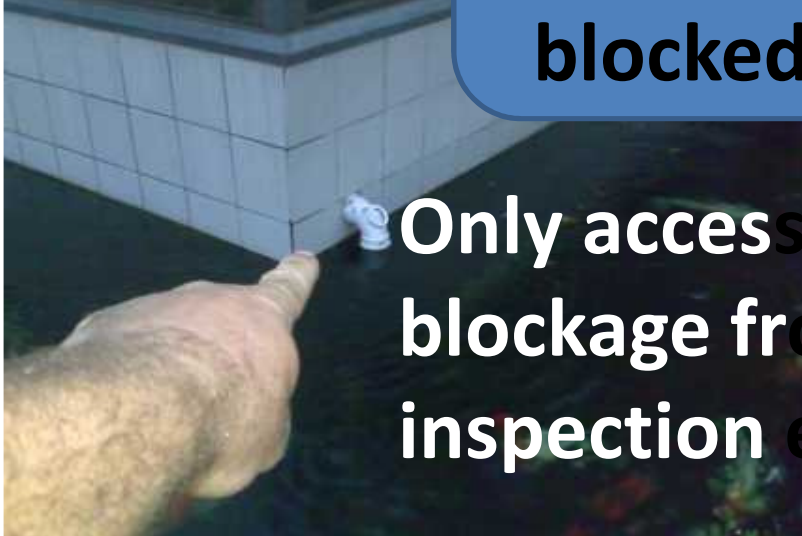
Only access to the blockage from this inspection eye below

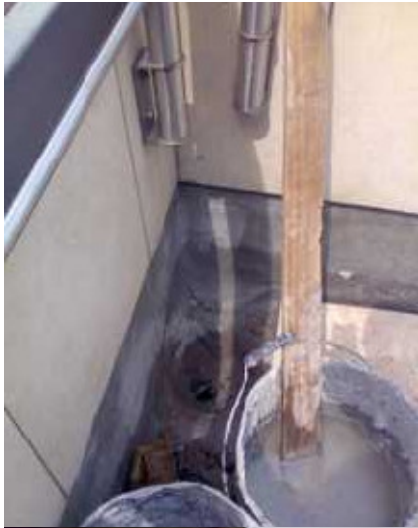
Debris left behind and the rest of wet tile adhesive and cement washed down into the drains

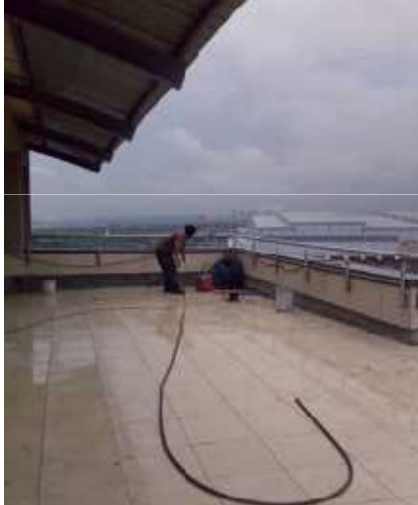
Mini high pressure jetting machine used To unblock and blast away loose cement that carbide tips broke up.

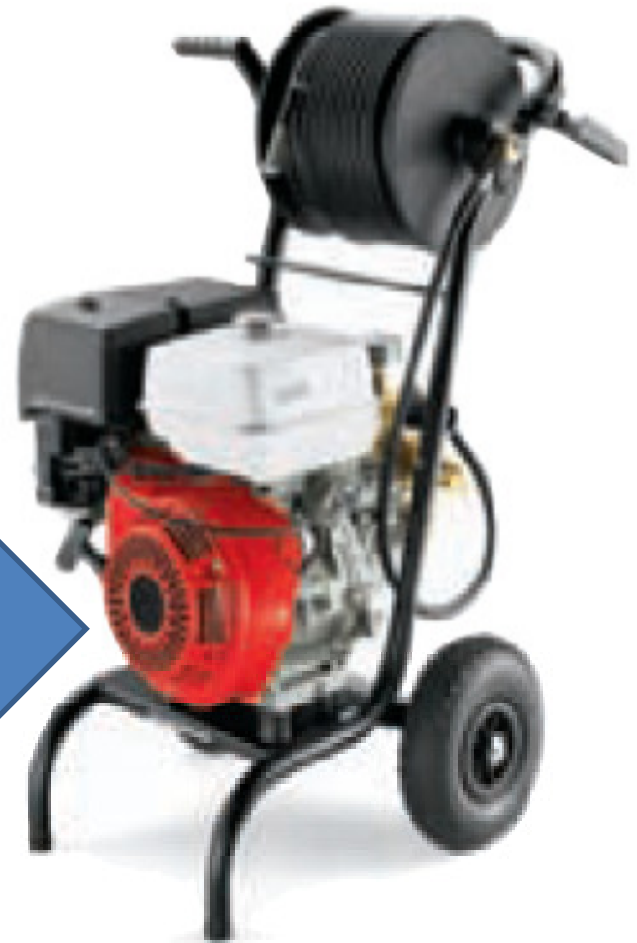
Spade shaped cutter wont work here so high pressure water is used with other concrete cutters too, driven by Rothenberger German drain cleaning machines

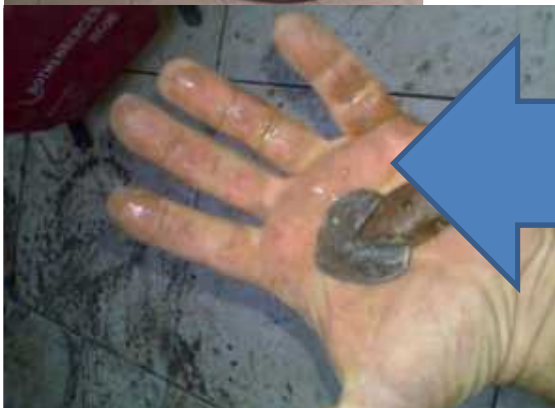
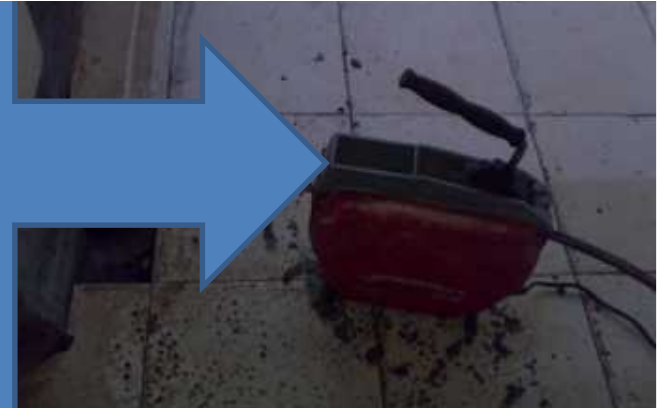
Cameras and machines inserted from below in the garden as well as above, first the machine cleans and then camera double checks the drain is actually cleared, before going on!

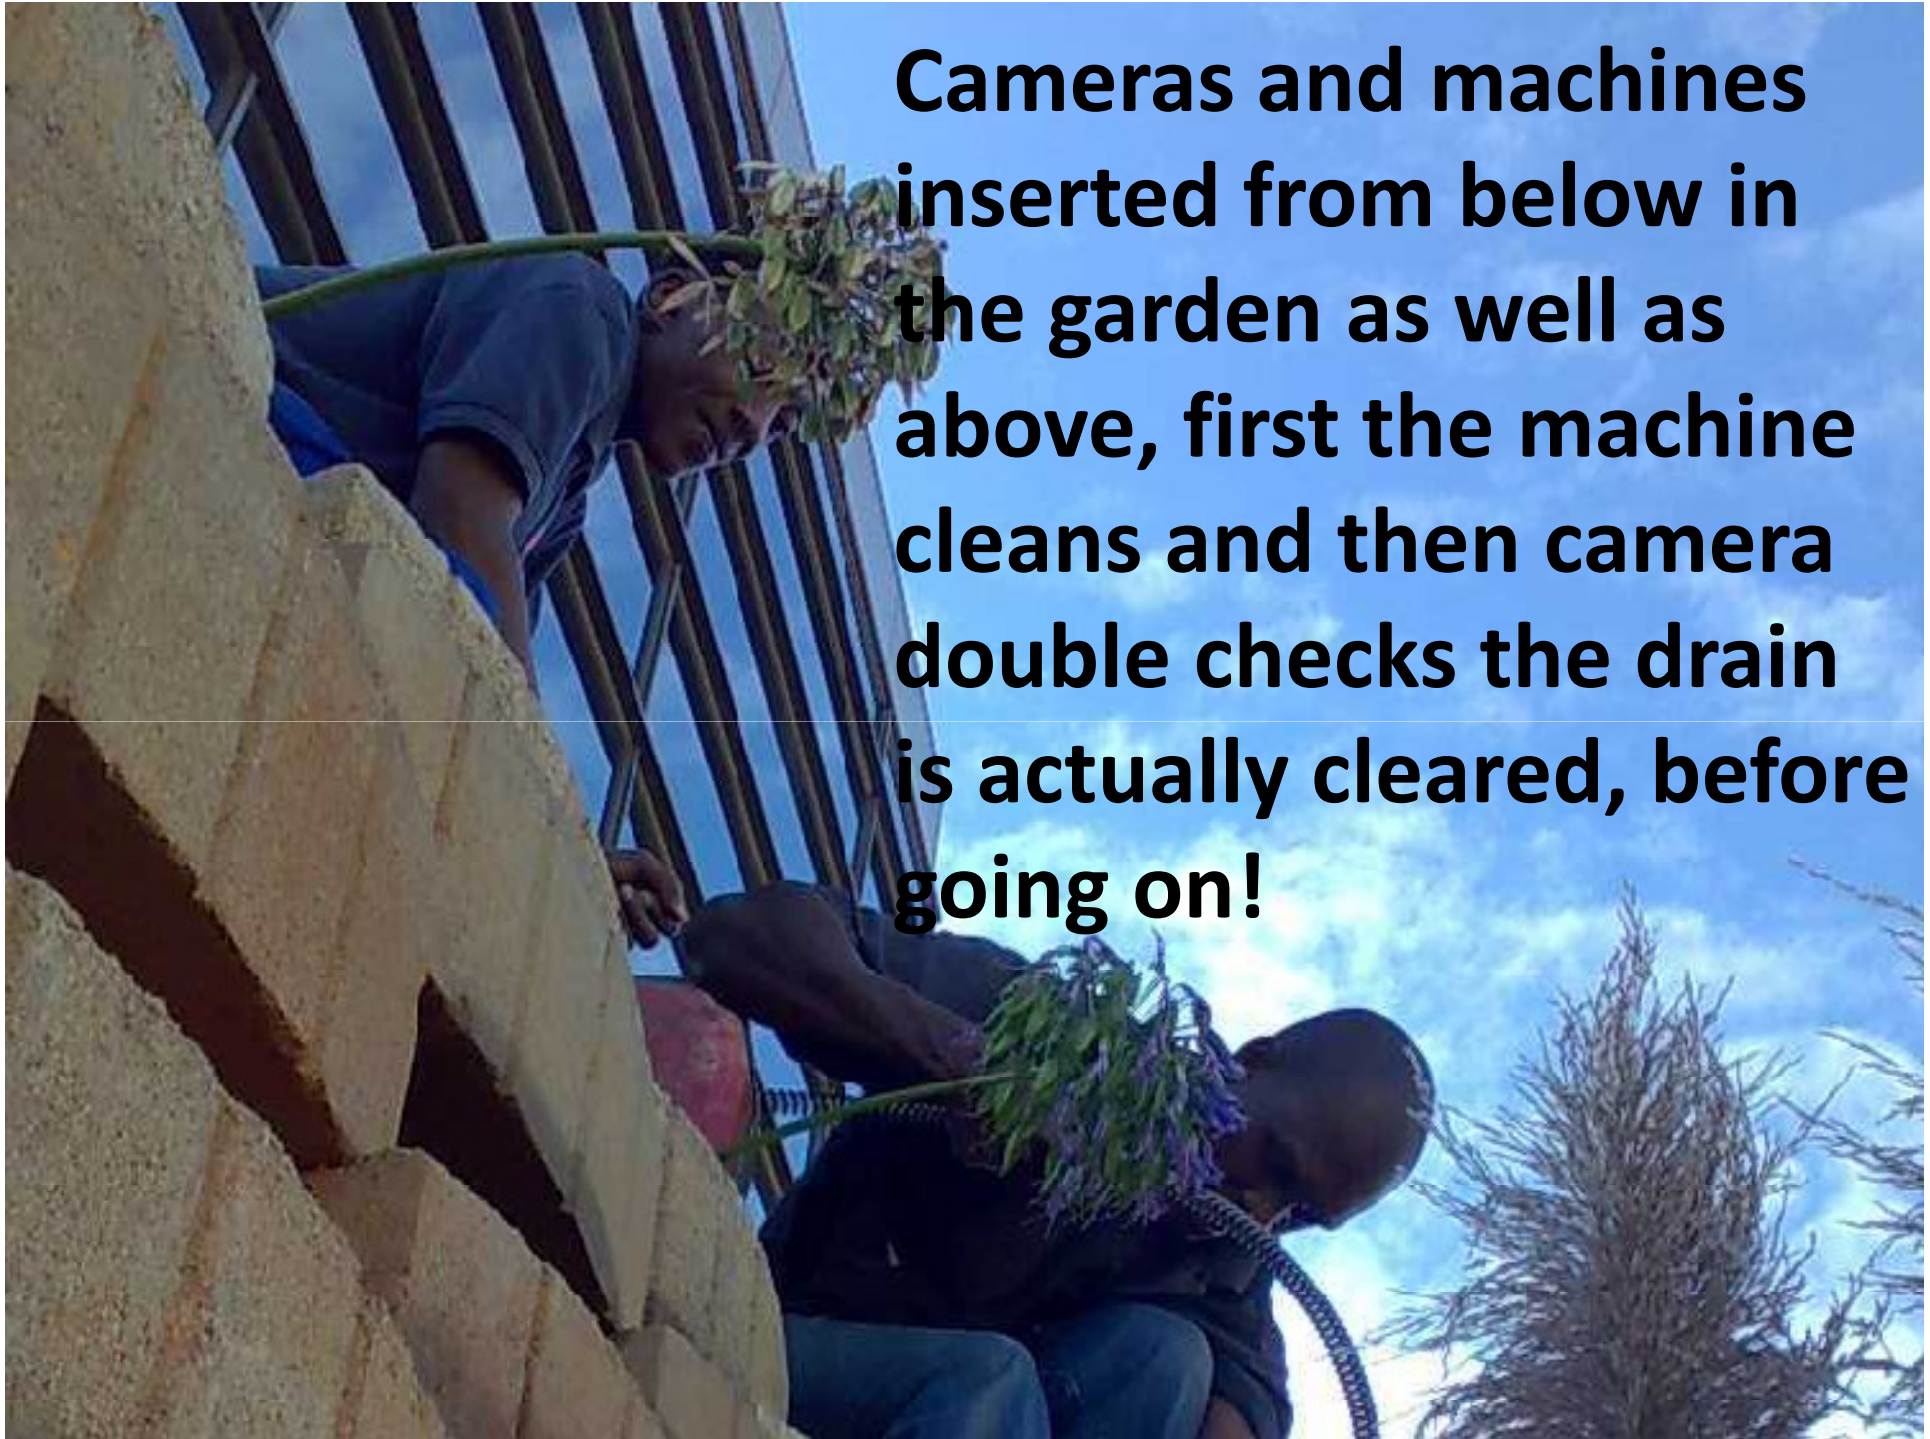
Bottle orger used to overcome full bore drains Rigid SR20 used to locate more difficult blockages

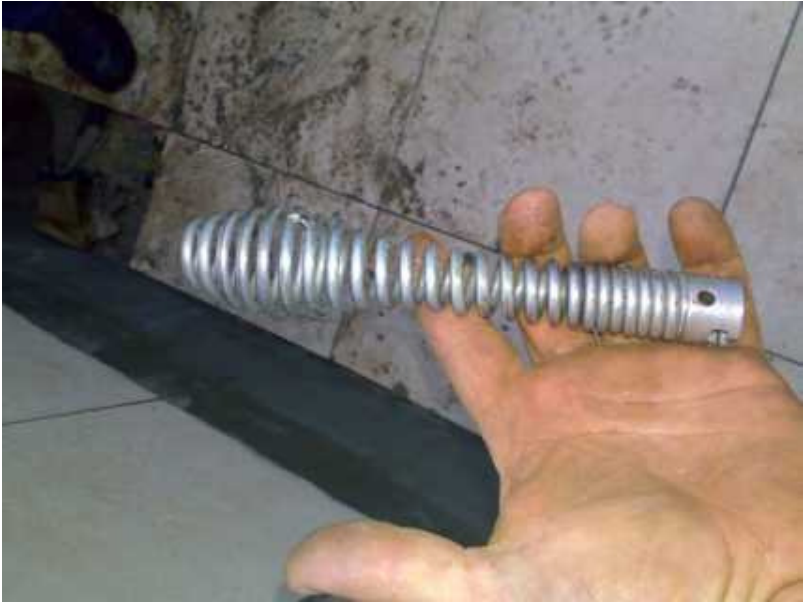
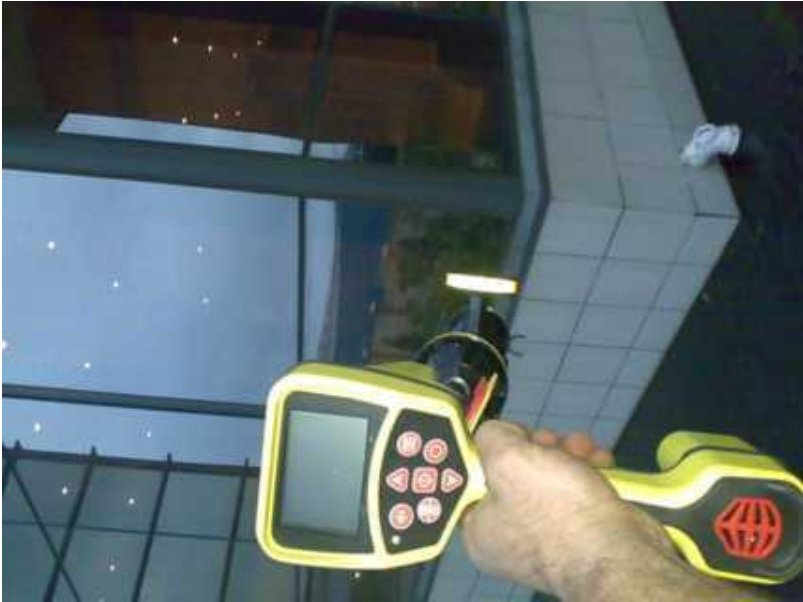
Staff on roof unblocking down pipes
